LAKE ELLYN DAM

( NDI ID NO. PA-00138  
DER ID NO. 6432 )

PHASE I INSPECTION REPORT  
NATIONAL DAM INSPECTION PROGRAM

JANUARY 1981

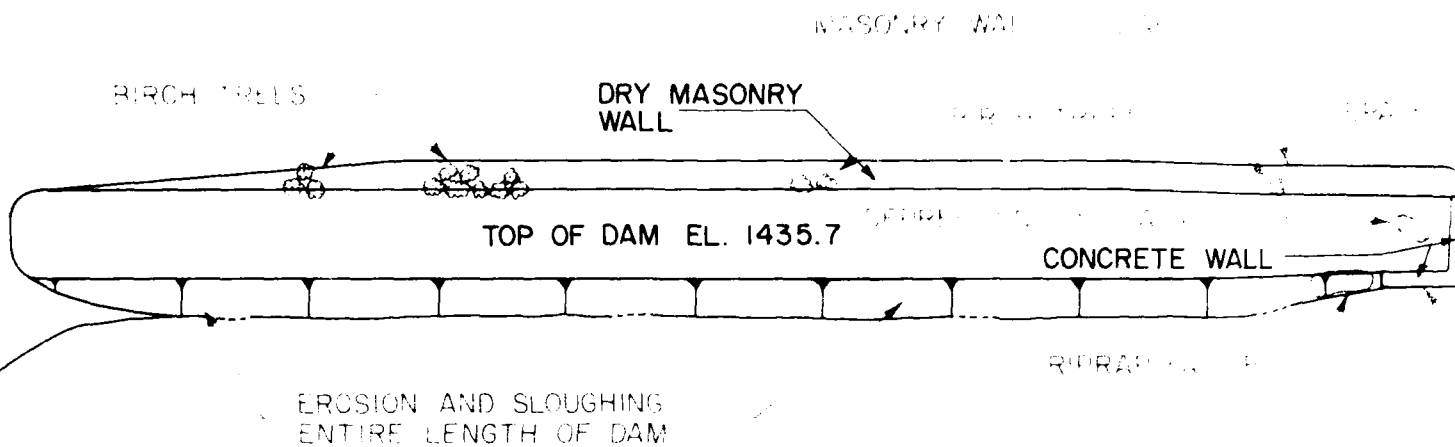
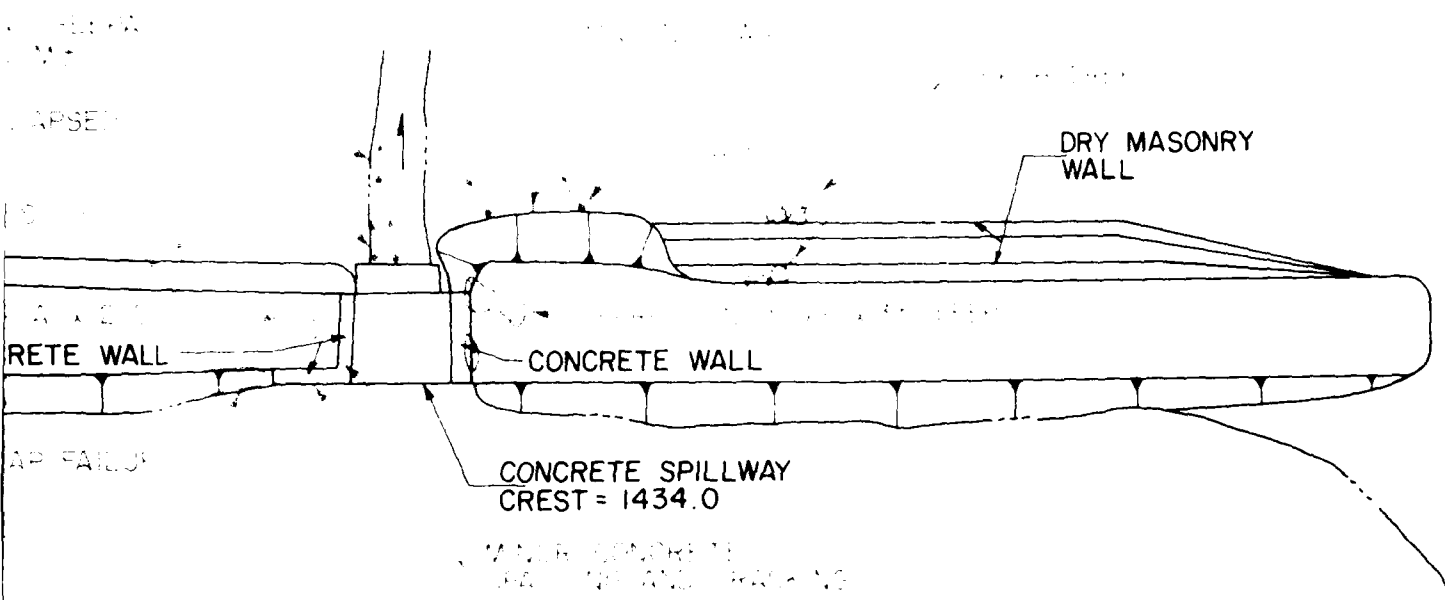
a. General. The overall appearance of the dam is poor. Some deficiencies were observed as noted below. A sketch of the dam with the locations of the deficiencies is presented on Exhibit B-1 in Appendix B. Survey information acquired for this Report is presented in Appendices B and E. Datum for the survey was taken at the spillway crest, elevation 1434.0. On the day of the inspection the pool was at elevation 1433.4.

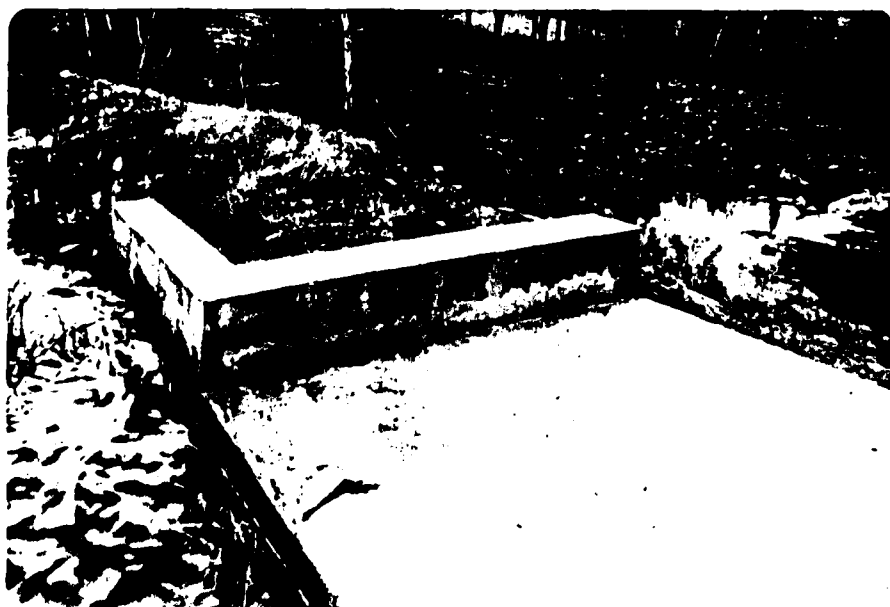
c. Appurtenant Structures. Physically the spillway is in fair condition (Photographs D, E and F). The left concrete wingwall on the upstream end of the spillway is spalled at the base. Some minor cracking of the left wall is evident. The spalling and cracking of the spillway walls is of no concern at the present time. The foundation for the spillway slab is uncertain but the spillway appears to have been constructed directly on the earthfill and masonry sections of the dam. The spillway discharges in a straight drop to the natural stream channel. Rock, logs, and debris cover the channel just downstream from the dam.

D. Spillway

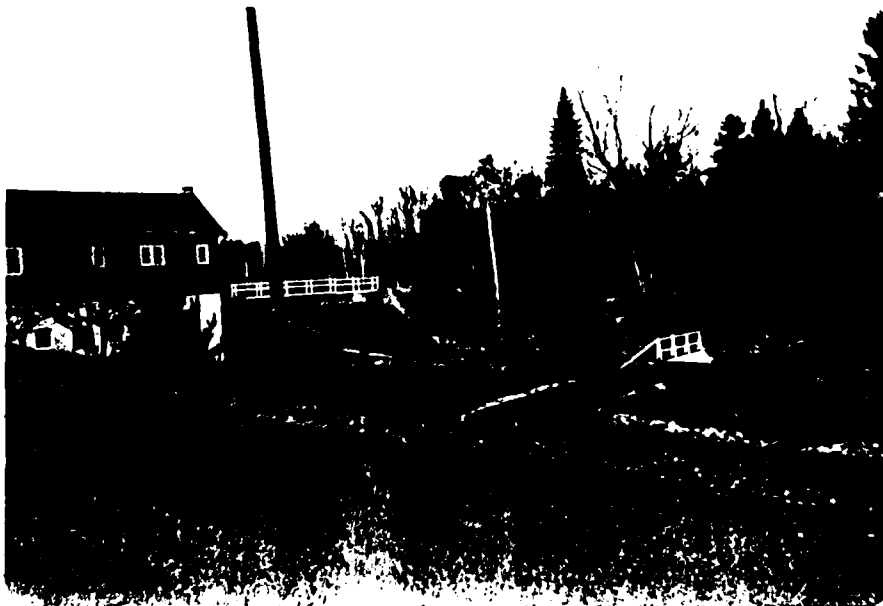
H. Craft Pond Dam - Two Miles  
Downstream
